TO: Gary Miller, Remedial Project Manager
U.S. Environmental Protection Agency Region VI

FROM: Barry Forsythe, Ph.D., Technical Liaison
U.S. Fish & Wildlife Service

DATE: 13 June 2005

RE: Site visit trip report, Gulfco Marine Maintenance Site

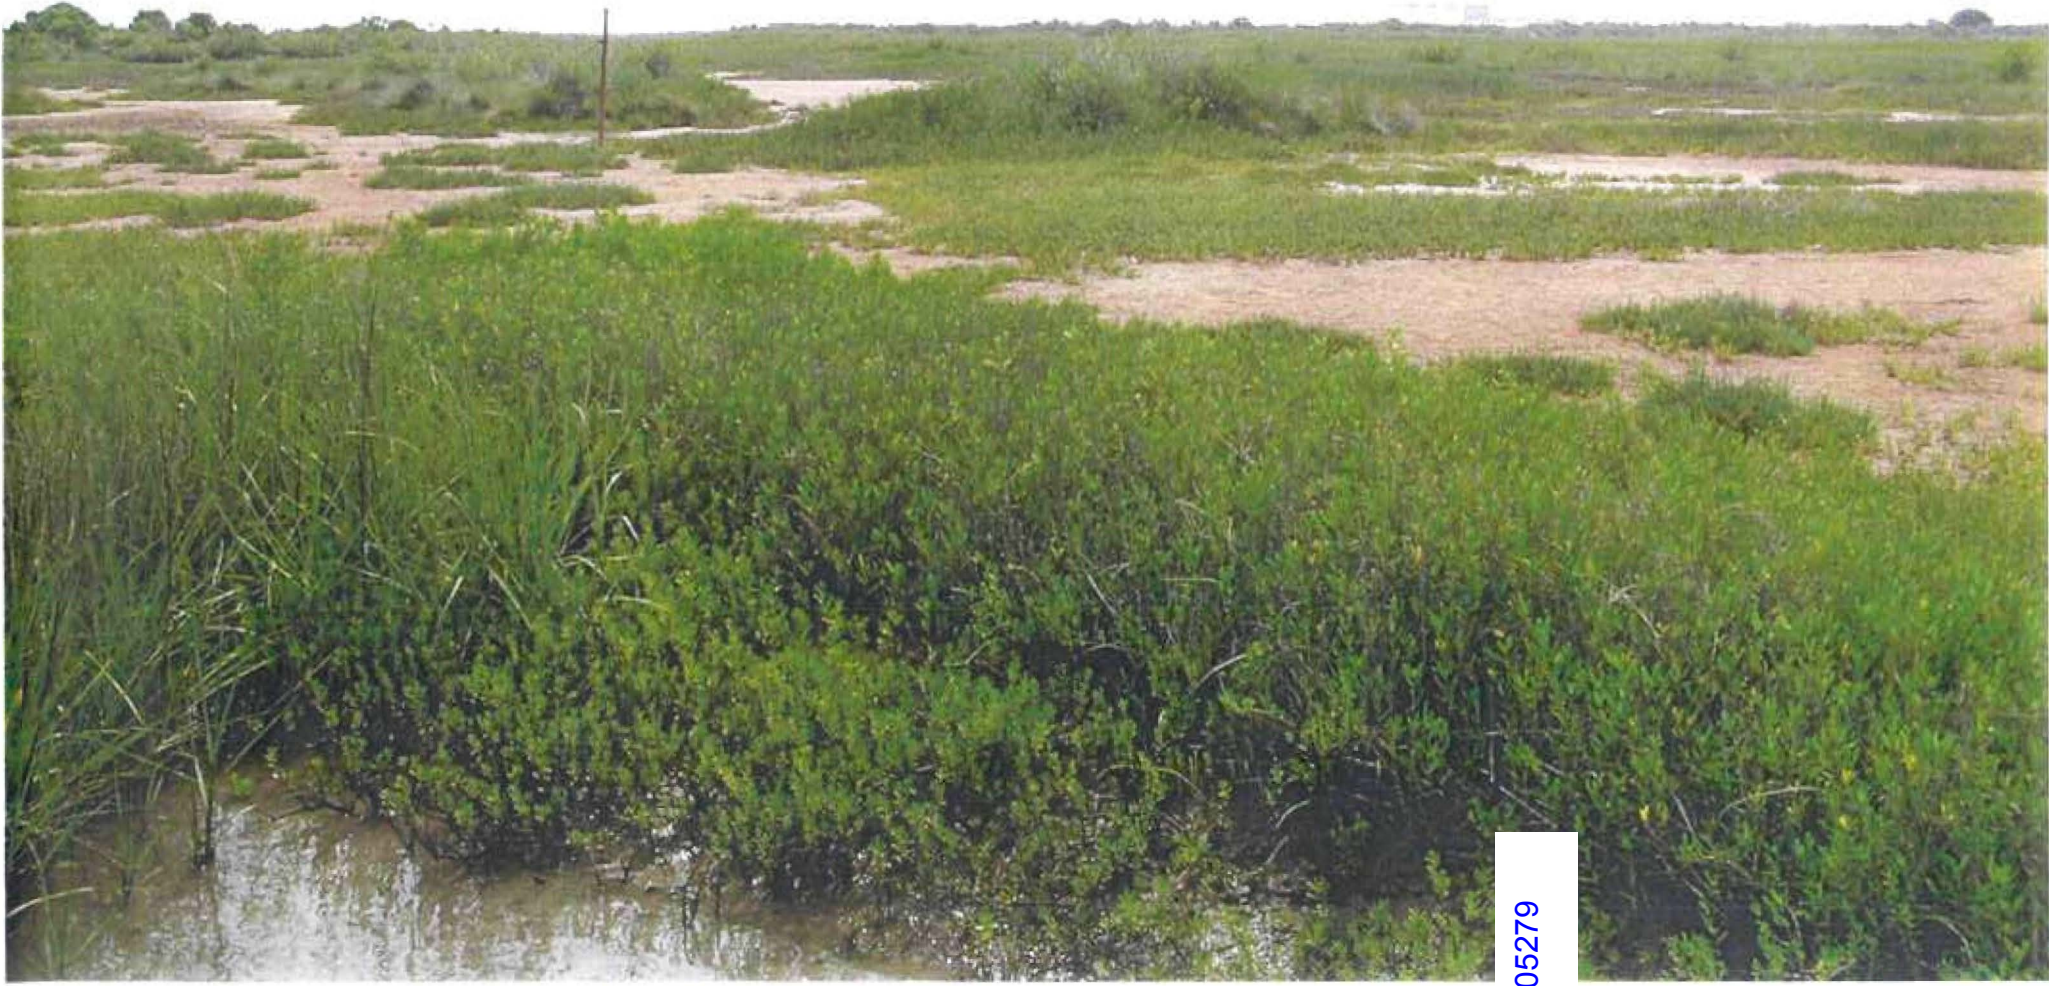
Table 1. Observations associated with Gulfco Marine Maintenance Site visit by USFWS personnel. Site numbers and lat./long. are associated with Figures 1 and 2.

6	N 28° 57.987' W 095° 17.249'	Second D/P on south shoreline slightly east of #5 where Portland cement dam was observed.
7	N 28° 58.008' W 095° 17.216'	Additional D/P on south shoreline near concrete slab.
8	N 28° 58.009' W 095° 17.205'	Additional D/P at west end of bulkhead facing Freeport Channel.
9	N 28° 58.041' W 095° 17.158'	D/P at culvert leading from southeast corner of site into Freeport Channel. Receives runoff from eastern portion of site.
10	N 28° 58.159' W 095° 17.342'	D/P from upland area (site tract located north of dividing paved road) into excavated pond near southeast corner.
11	N 28° 58.132' W 095° 17.359'	Southernmost PVC screen pipe occurring in suspected waste pit area immediately adjacent to excavated pond.

Site Number	Lat./Long.	Comment
12	N 28° 58.154' W 095° 17.375'	Northernmost PVC screen pipe at abovementioned area.
13	N 28° 58.170' W 095° 17.401'	Point at or near north property line where D/P connects suspected waste pit with extensive marshland occurring between site and oxbow to north.
14	N 28° 58.118' W 095° 17.459'	Point at estimated property line being northwest of ramp dry dock (on south side of dividing paved road) within D/P leading from site's north tract to extensive marshland situated north of site and dominant D/P from site to oxbow.
15	N 28° 58.040' W 095° 17.457'	D/P on west side of site (north tract) leading to offsite runoff area west of site.
16	N 28° 57.982' W 095° 17.416'	Road ditch at northwest corner of south tract adjacent to paved road dividing south tract from north tract.
17	N 28° 58.090' W 095° 17.290'	Culvert from road ditch leading to north tract under paved road.
